Fluvial Geomorphological and Meander Belt Width Assessment

**11 Main Street
Puslinch, Ontario**

GEO Morphix Project No. 22099

Report Title: Fluvial Geomorphological and Meander Belt Width
Assessment, 11 Main Street, Puslinch, Ontario

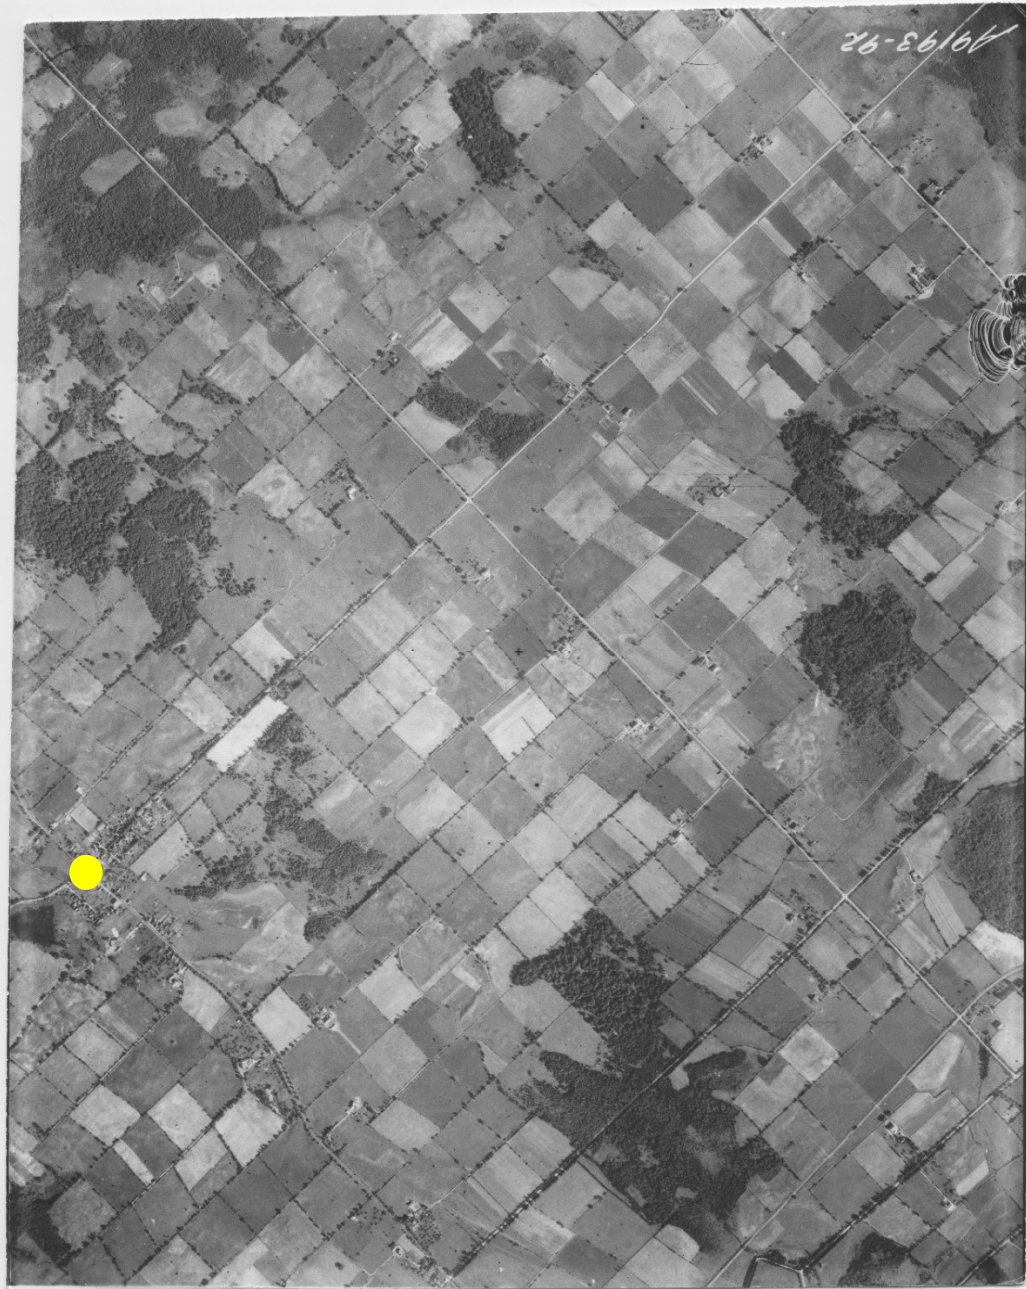
Year: 1945

Scale: 1:20,000

Source: National Air Photo Library

Location: Queen Street and Calfass Road, Town of Puslinch (Yellow Dot)

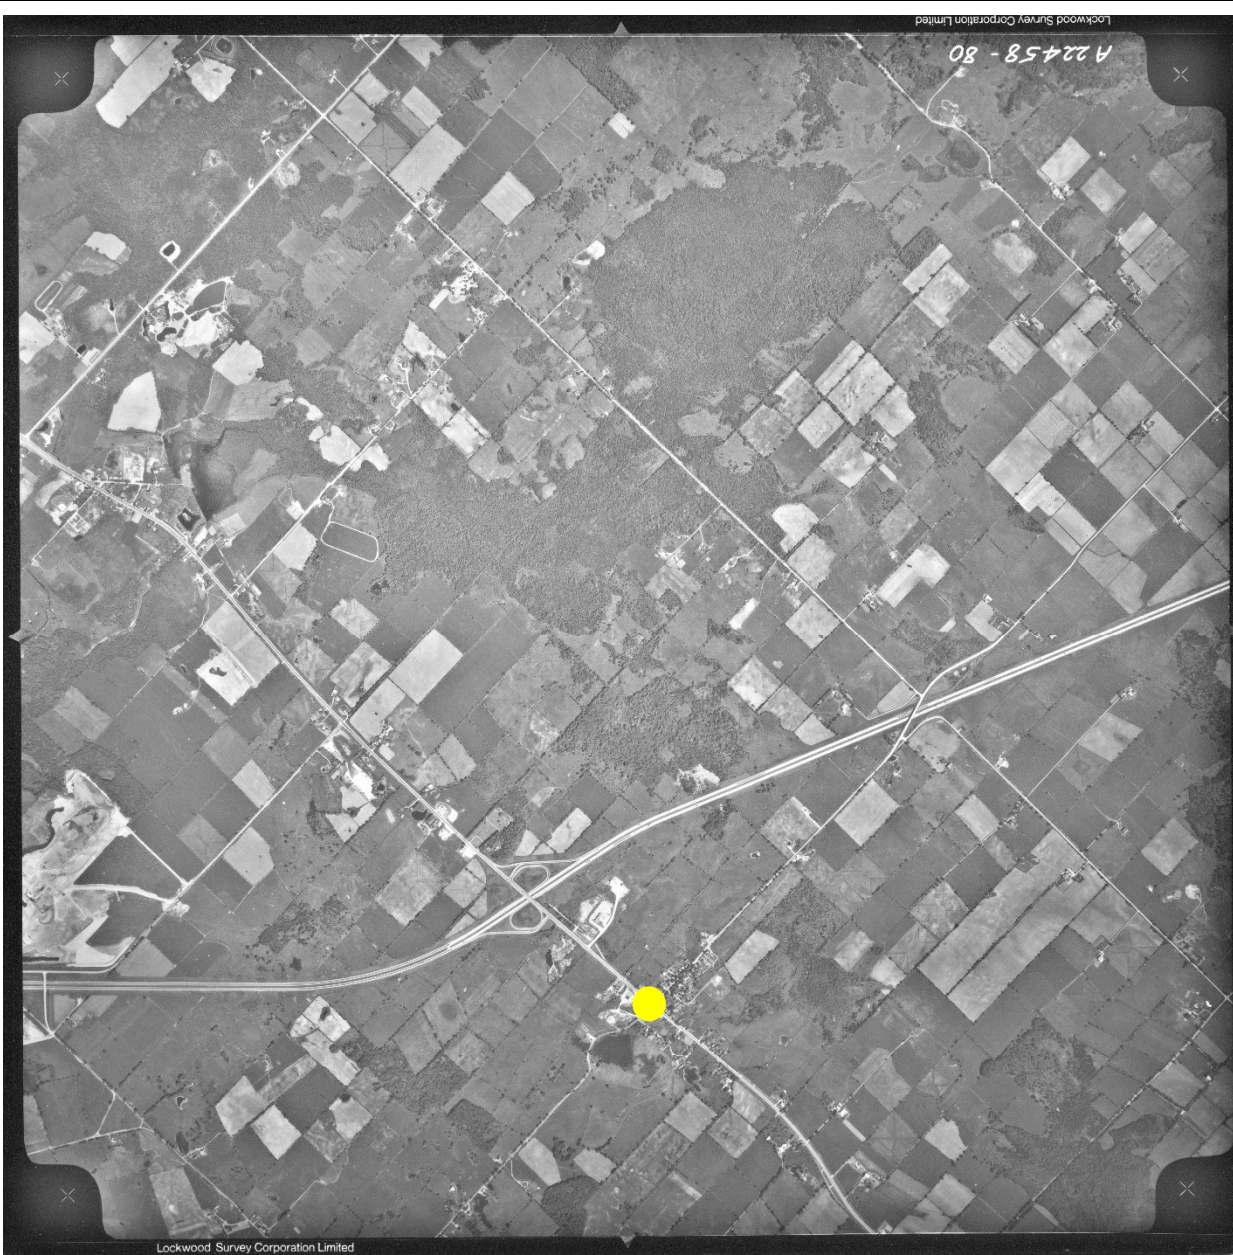
Year: 1972

Scale: 1:25,000

Source: National Air Photo Library

Location: Queen Street and Calfass Road, Town of Puslinch (Yellow Dot)

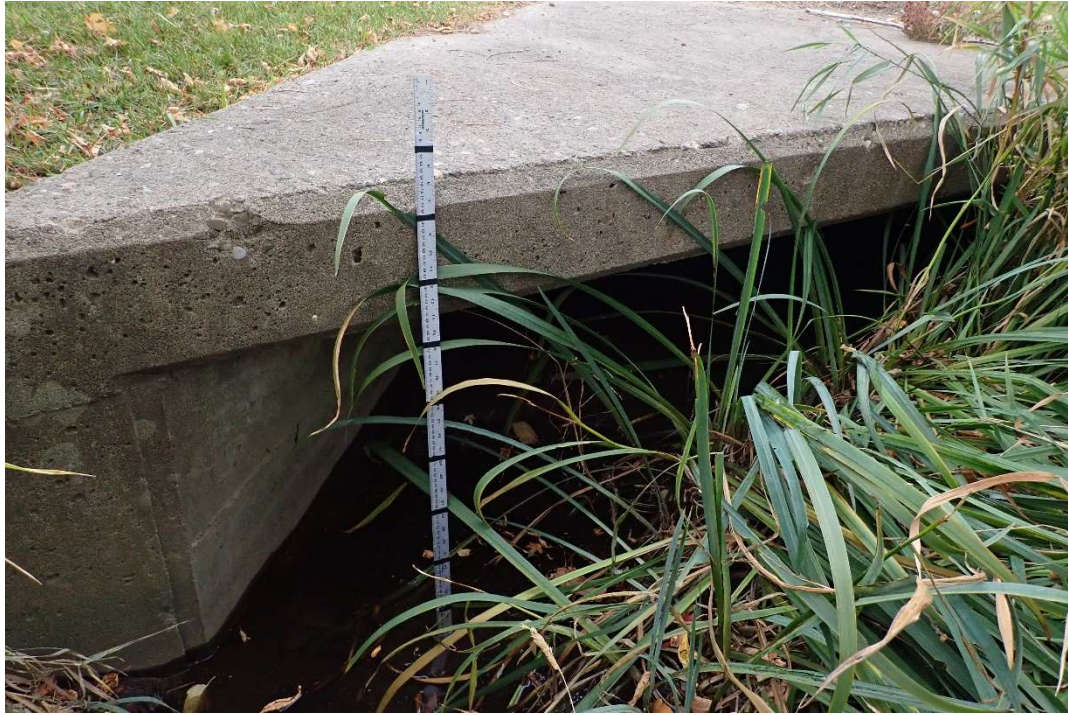
Tributary of Bronte Creek
Reach TBC-1
Photo 1

Highway 6 Concrete box culvert at the upstream extent of TBC-1

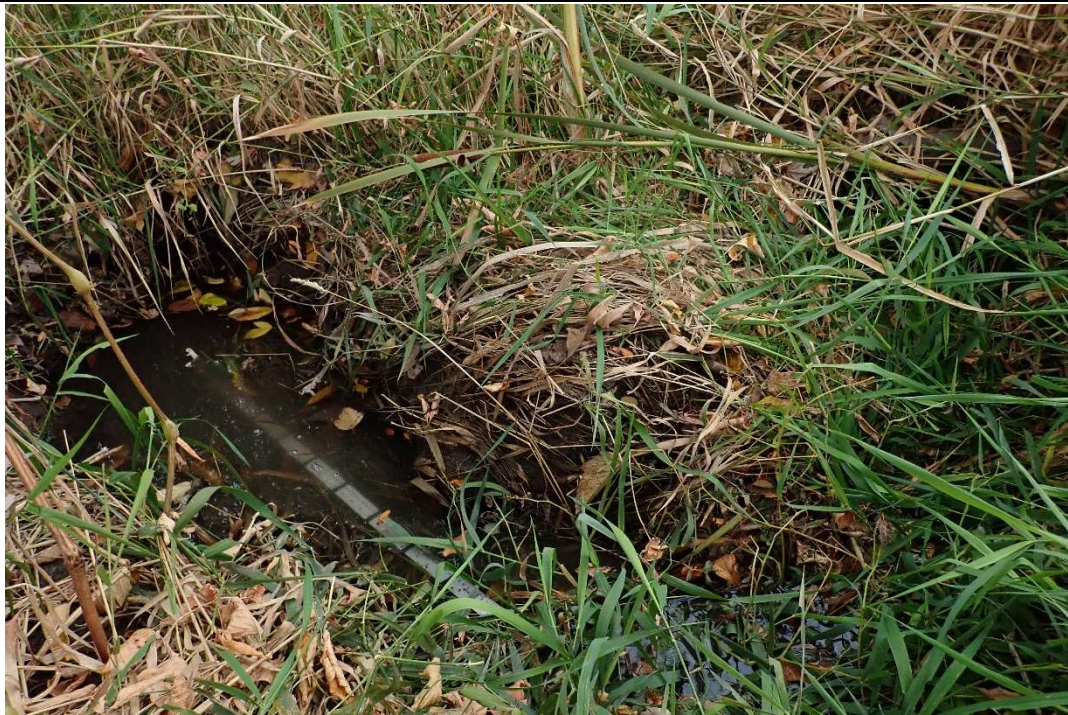
Tributary of Bronte Creek
Reach TBC-1
Photo 2

Defined bankfull conditions downstream of culvert. Metre stick for scale.

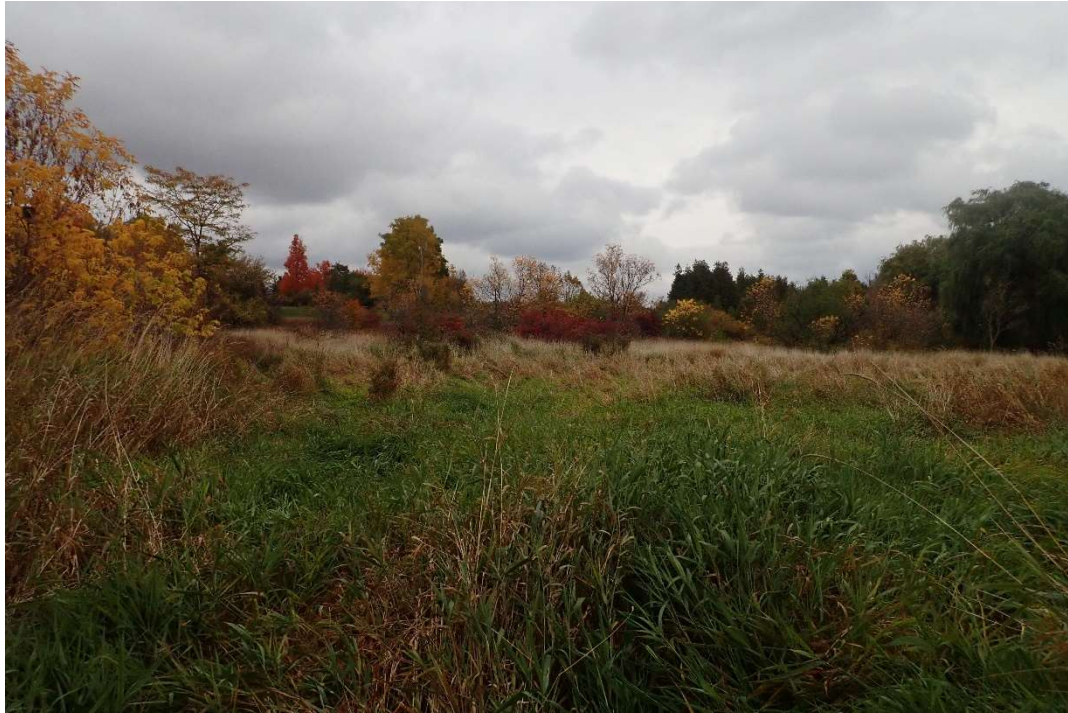
Tributary of Bronte Creek
Reach TBC-1
Photo 3

The riparian area consisted mainly of tall grasses with sparse herbaceous shrubs and trees. Bankfull channel was poorly defined throughout.

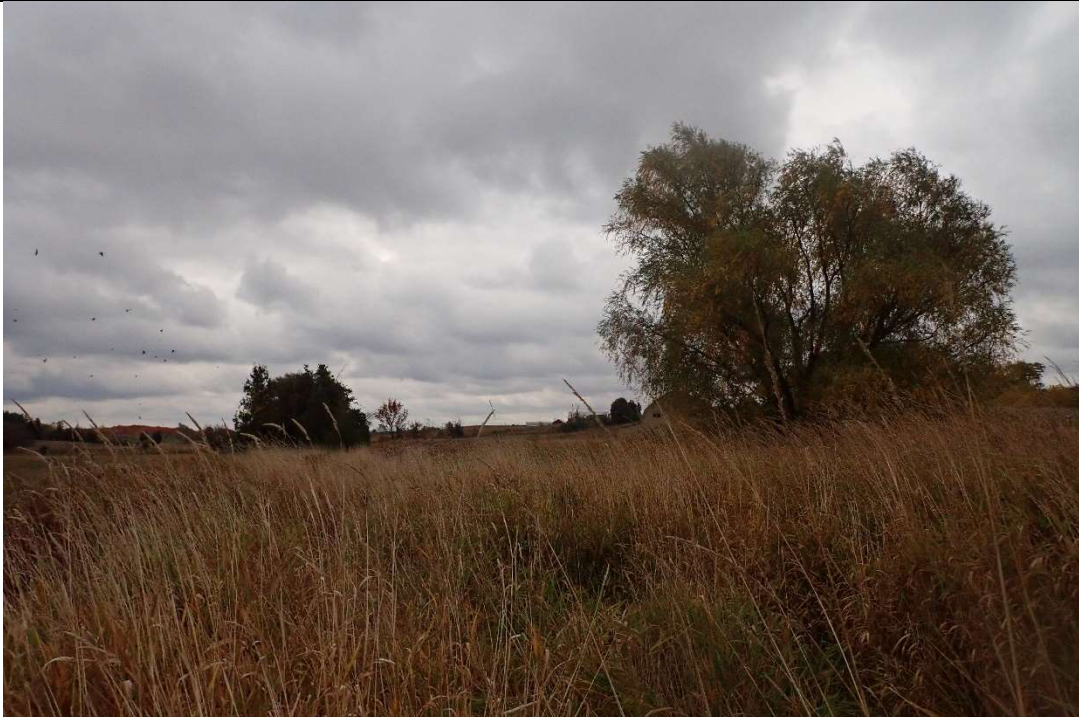
Tributary of Bronte Creek
Reach TBC-1
Photo 4

Downstream of reach as it continues to flow off property boundaries. Outside of pictured grassy riparian area is agricultural field.

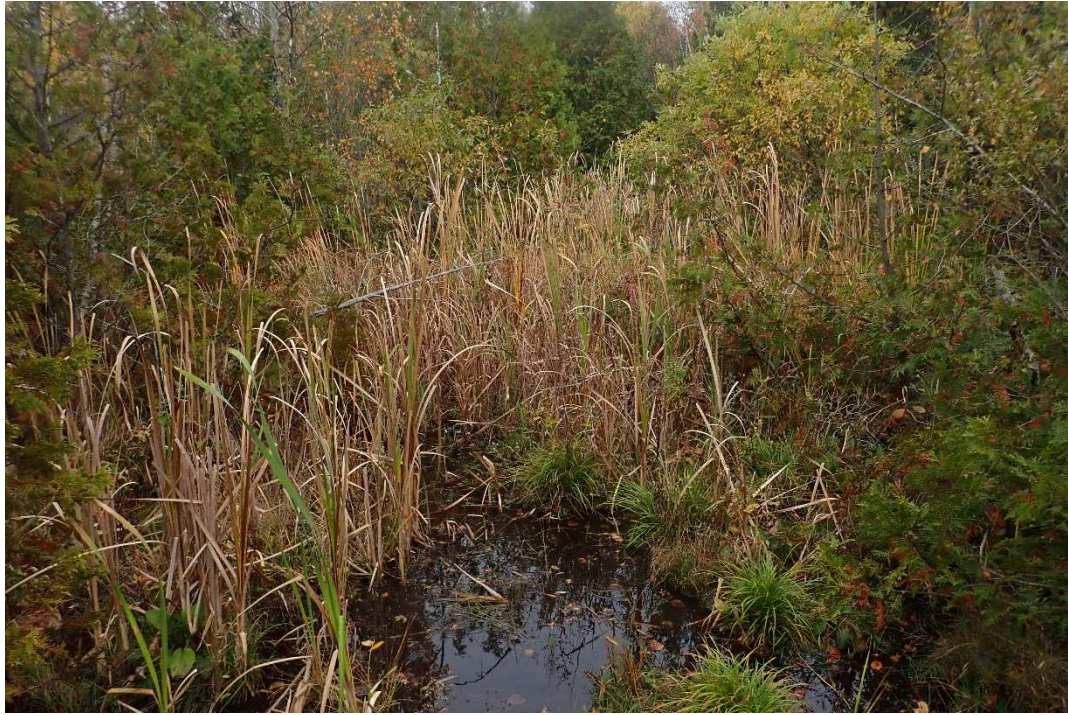
Tributary of Bronte Creek
Reach TBC-2
Photo 5

Hummocky areas with instream grasses and pooled, standing water is typical condition along Reach TBC-2

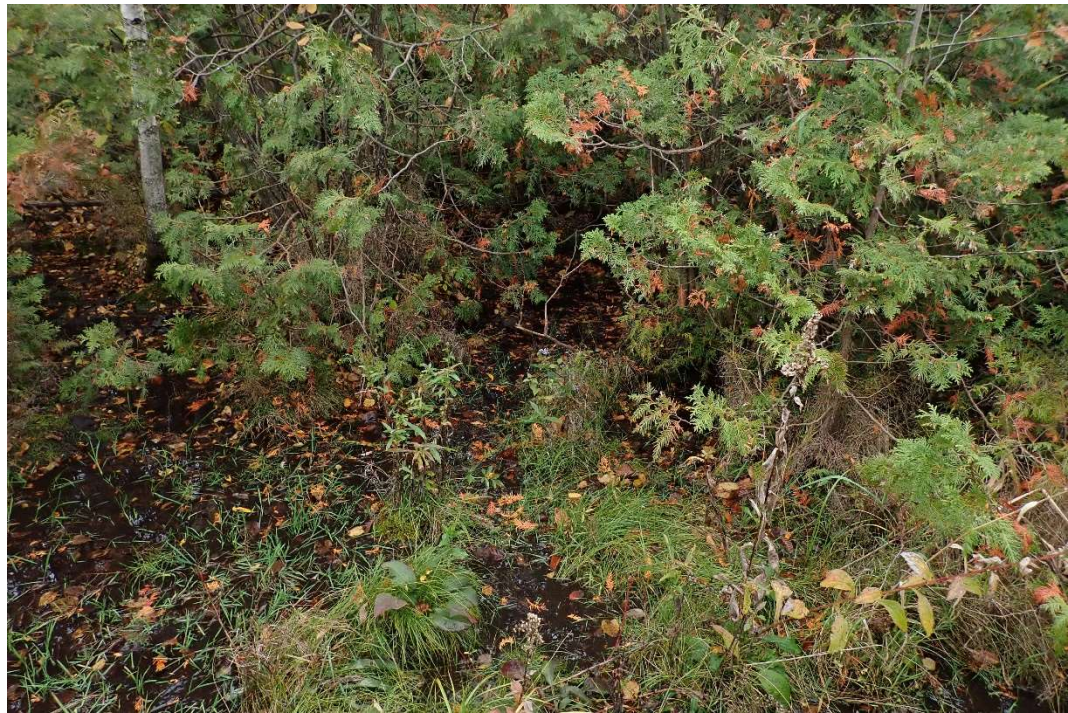
Tributary of Bronte Creek
Reach TBC-2
Photo 6

Grassy hummocks and trees throughout pools of water. No defined bankfull channel present along Reach TBC-2

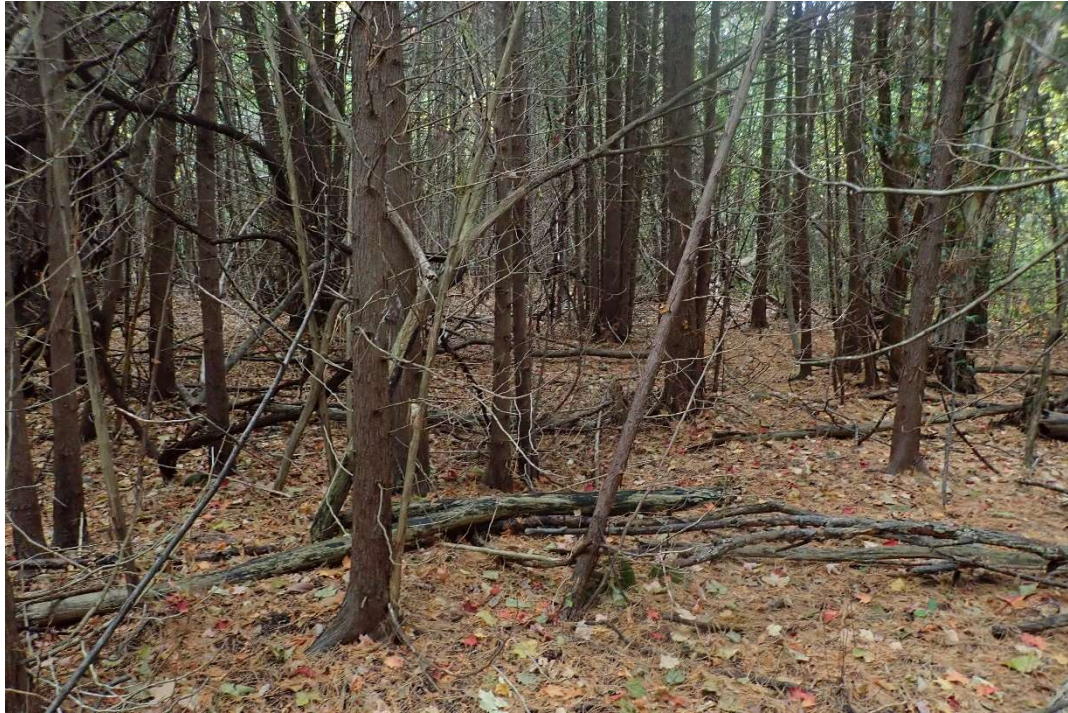
Tributary of Bronte Creek
Reach TBC-3
Photo 7

The riparian zone of Reach TBC-3 contained wooded area. No bankfull channel or flow paths observed in the upstream sections.

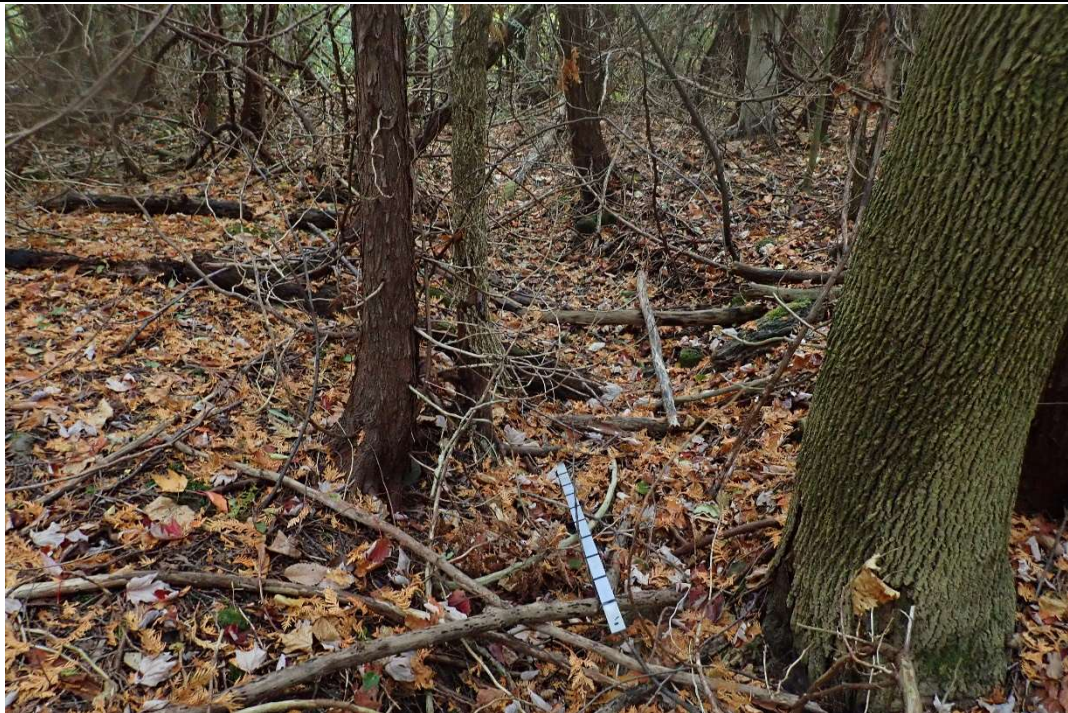
Tributary of Bronte Creek
Reach TBC-3
Photo 8

A minor flow path was observed in the very downstream extent of the study site, presumed to be associated with mapped stream Reach TBC-3.

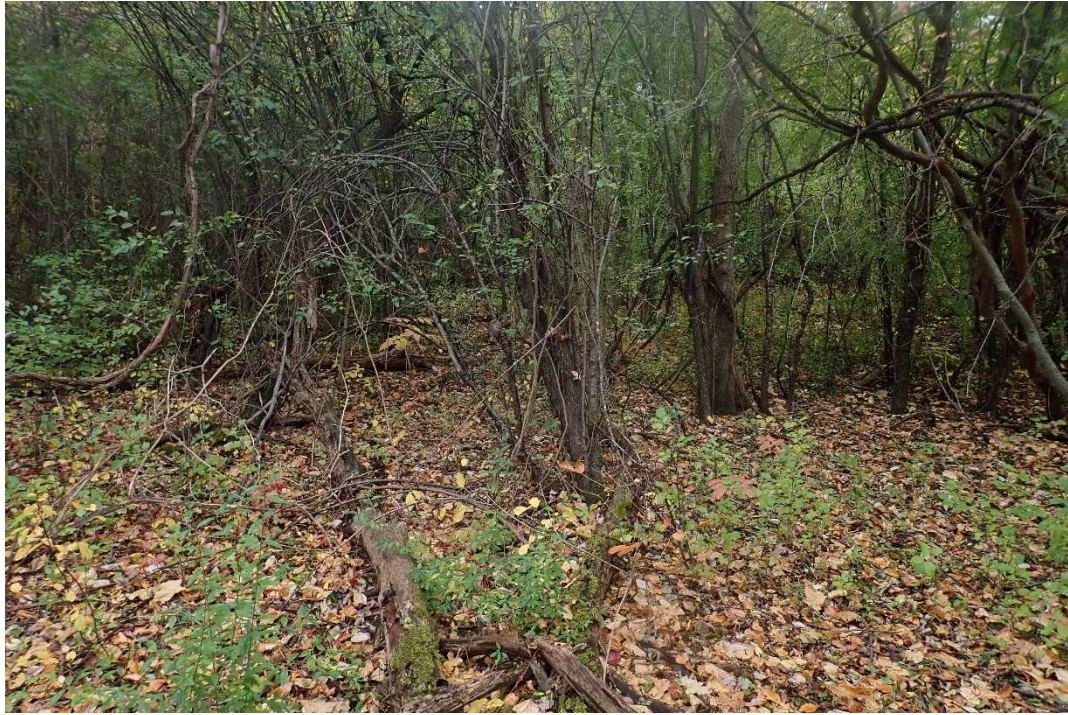
Tributary of Bronte Creek
Reach TBC-3a
Photo 9

The riparian area consisted of wooded area. No defined flow path observed in association with mapped stream Reach TBC-3a

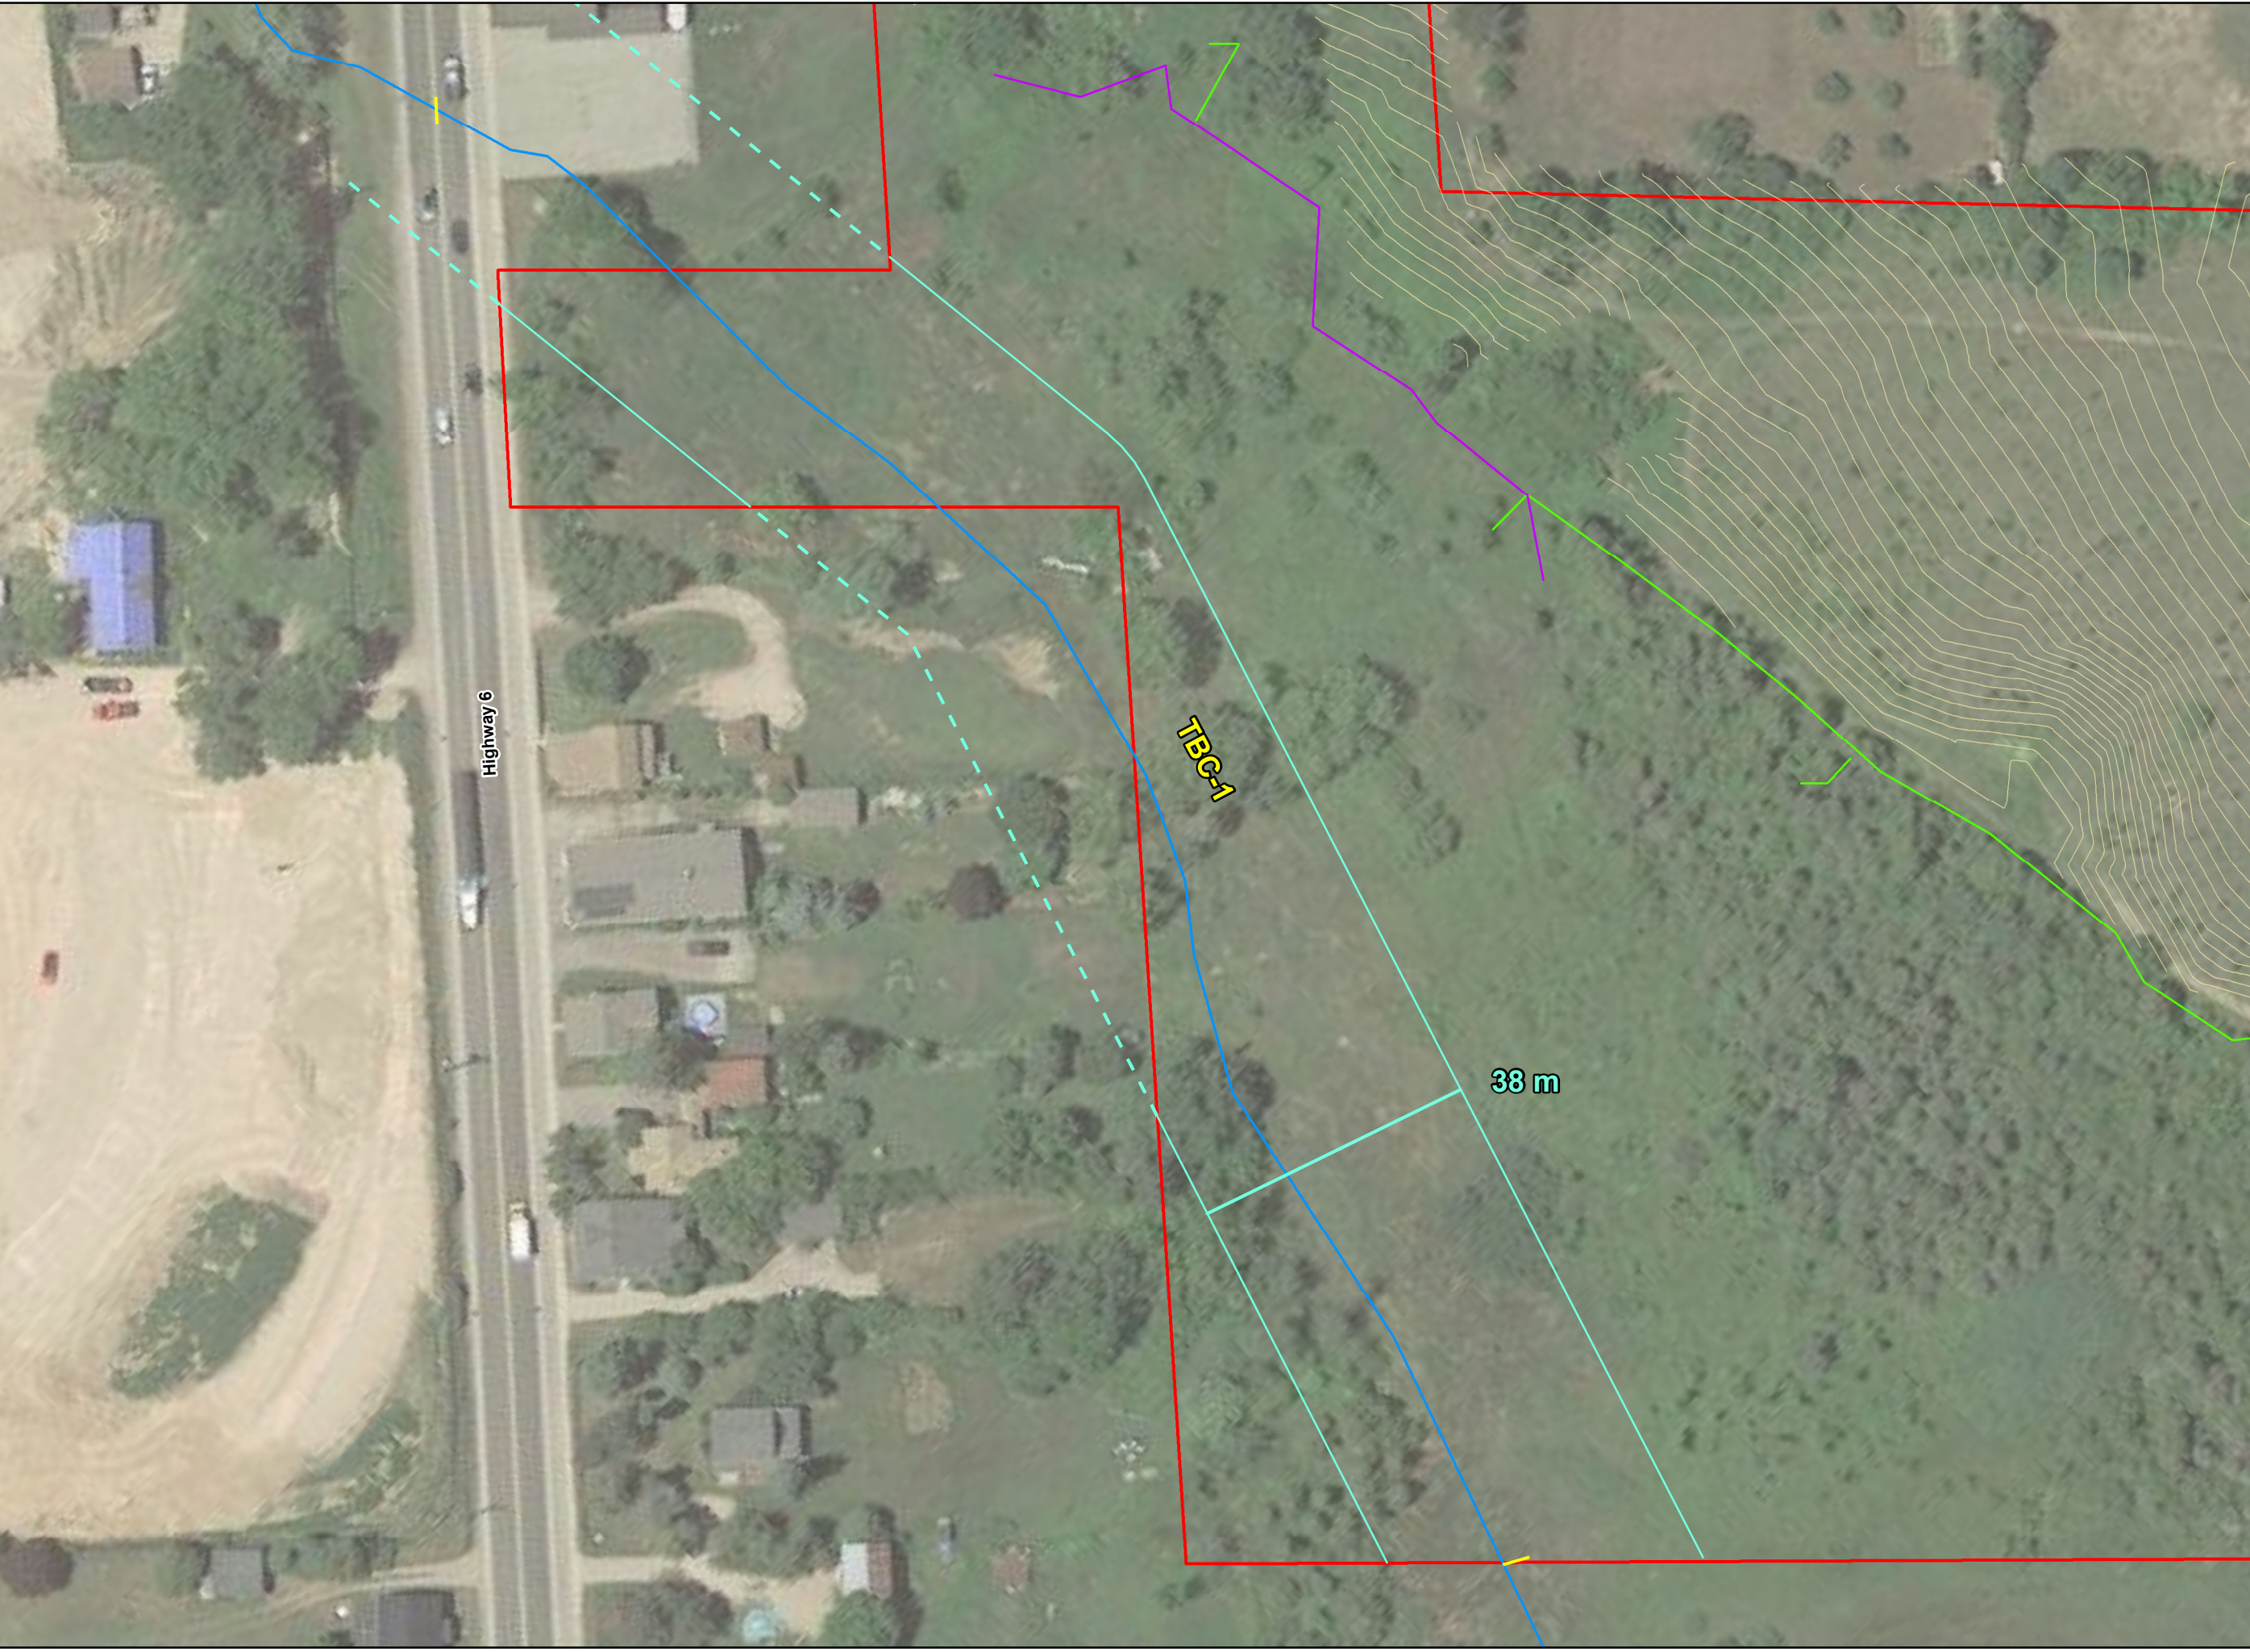
Meander Belt Width Delineation

For **Reach TCB-1**, we recommend applying a meander belt width of 38 m, following the Toronto Region Conservation Agency (TRCA) model. The TRCA model considers contributing drainage area, flows, and local gradients rather than relying on bankfull channel geometry alone. The 38 m meander belt width is conservative in nature given that there is limited channel definition and very limited erosion potential along this reach. The recommended meander belt width also falls within the current staked wetland boundary and is therefore not a limiting constraint for the proposed development. A map of the meander belt width delineation is provided in **Appendix E**.

For **Reach TCB-1**, the watercourse flowing through the western portion of the subject site, a meander belt width of 38 m is recommended. The meander belt width was determined through an empirical modelling exercise. The final meander belt width is conservative given that the channel is small, poorly

defined, and shows limited evidence of erosion or adjustment. It should be noted that the meander belt width also sits within an existing staked wetland boundary and is not a limiting constraint on the proposed development.
